**Pre-Renovation Hazardous Building Materials Survey  
of  
1475 Edmonton Street, Prince George, BC**

**March 23<sup>rd</sup>, 2026**

**Prepared For:  
Northern Health  
c/o Lloyd Nordin, EIT – Project Coordinator, Capital Projects**

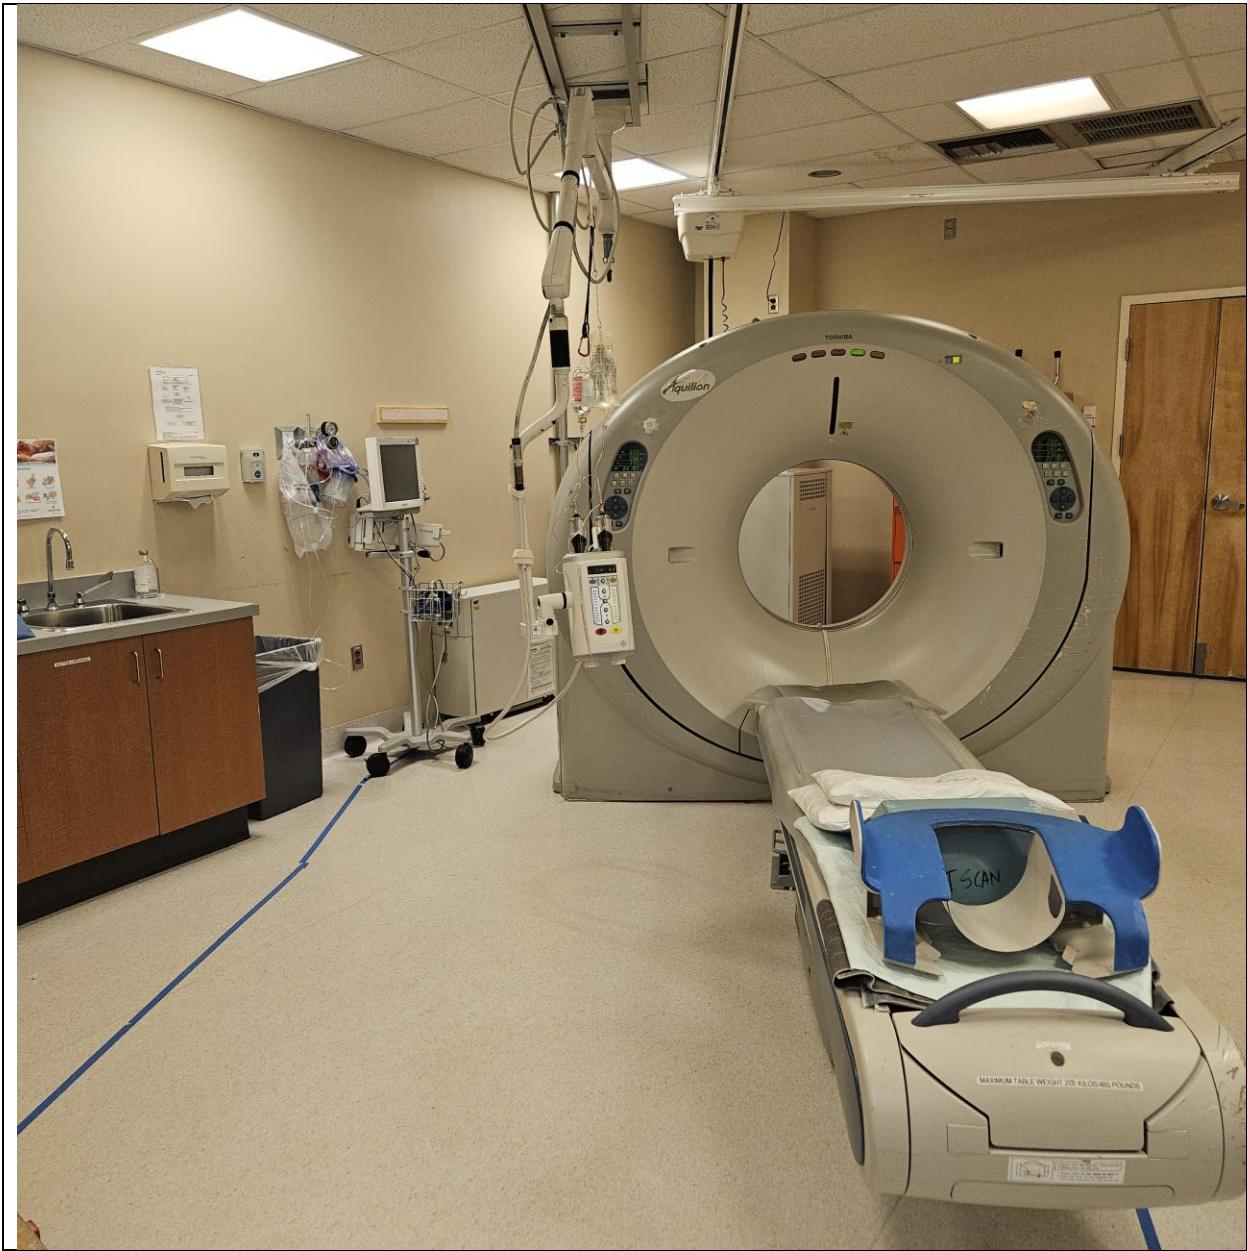
| <b>Photo 1</b> | <b>Date:</b> 17-Mar-2026 | <b>Location:</b> CT Scan Room 1 |

| <b>Description:</b> View showing floor, wall and ceiling finishes. | | |
